Restoration of a Coastal Wetland at Prisoners Harbor, Santa Cruz Island, Channel Islands National Park, California

Source: *Monographs of the Western North American Naturalist*, 7(1) :
442-454

RESTORATION OF A COASTAL WETLAND AT PRISONERS HARBOR, SANTA CRUZ ISLAND, CHANNEL ISLANDS NATIONAL PARK, CALIFORNIA

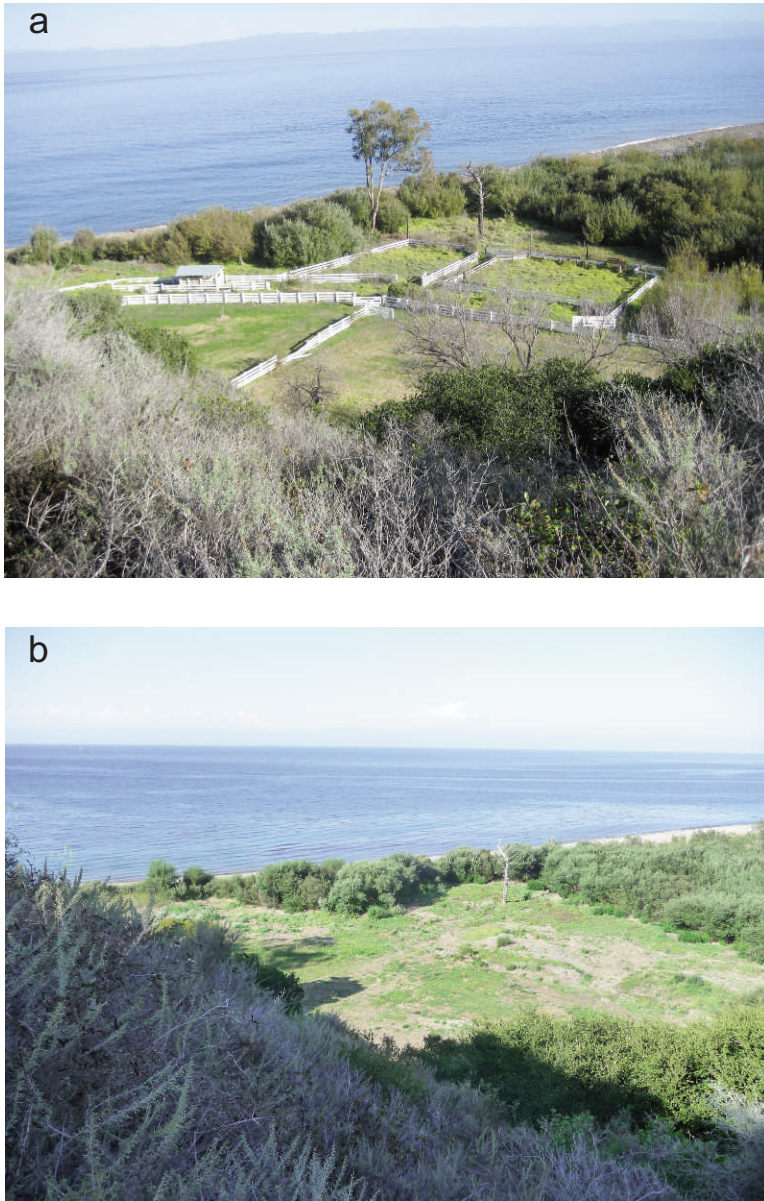
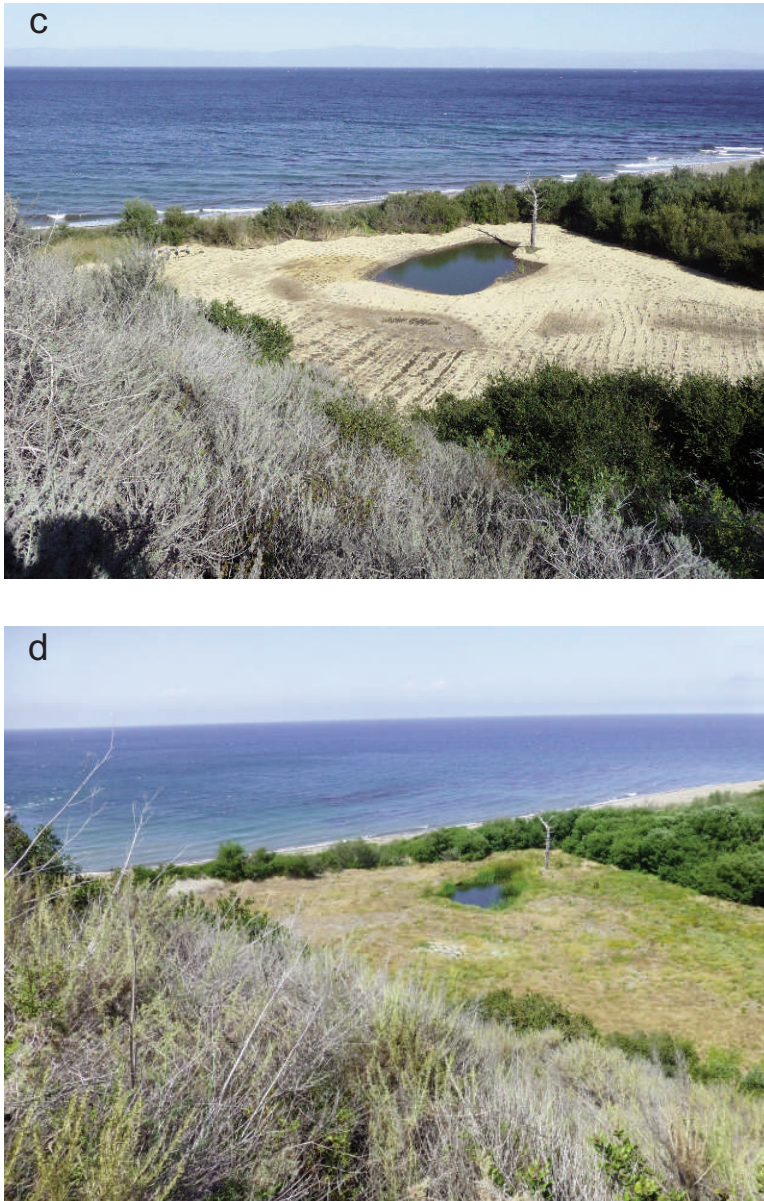
Fig. 4. Prisoners Harbor restoration area looking northeast: **a**, prior to project implementation in January 2010; **b**, prior to excavation in September 2011; **c**, immediately after native plant installation in December 2012; **d**, 18 months after project implementation in June 2013.

Table 1 shows the results for $1 \times 1\text{-m}$ quadrat vegetation monitoring in 2012 compared to 2013. Of the 8 herbaceous species planted, abundance (% frequency) of one species, *Baccharis douglasii*, increased significantly from 1.3% to 4.4% (chi-square value $P = 0.01$). There was no significant change in *D. spicata*, *Juncus mexicanus*, *S. californicus*, *Schoenoplectus maritimus*, and *Schoenoplectus pungens*. *Juncus patens* declined in abundance significantly, and *Juncus xiphioides* was not observed during 2013 monitoring (chi-square value $P = 0.02$ and $P = 0.00$, respectively). Photomonitoring also documented vegetation change on a landscape scale over this period (Fig. 4).
