Landslide Hazard and Risk Zonation Mapping in the Río Grande Basin, Central Andes of Mendoza, Argentina

Source: Mountain Research and Development, 22(2) : 177-185

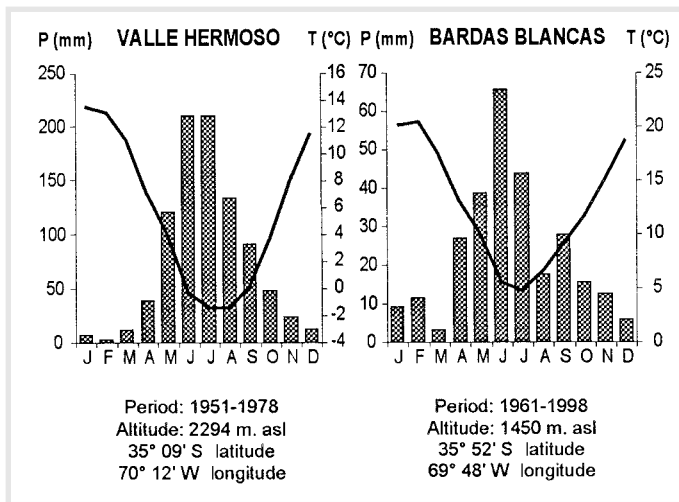
FIGURE 2 Monthly mean precipitation and temperature in Valle Hermoso and Bardas Blancas meteorological stations.

There are 2 meteorological stations in the zone, with interrupted records: (1) Valle Hermoso (35°09'S, 70°12'W) at 2294 m, and (2) Bardas Blancas (35°52'S, 69°48'W) at 1450 m. The mean monthly precipitation and temperature records show 2 well-defined periods, one in winter and the other in summer (Figure 2). The monthly mean maximum precipitation coincides with the monthly mean minimum temperature. In Valle Hermoso the mean monthly temperature from June to August is below 0°C. At this station the higher monthly precipitation occurs in the winter as snow, whereas in Bardas Blancas it can be snow or rain and occurs from May to June. Annual mean precipitation varies from 400 mm in Bardas Blancas to 940 mm in Valle Hermoso.

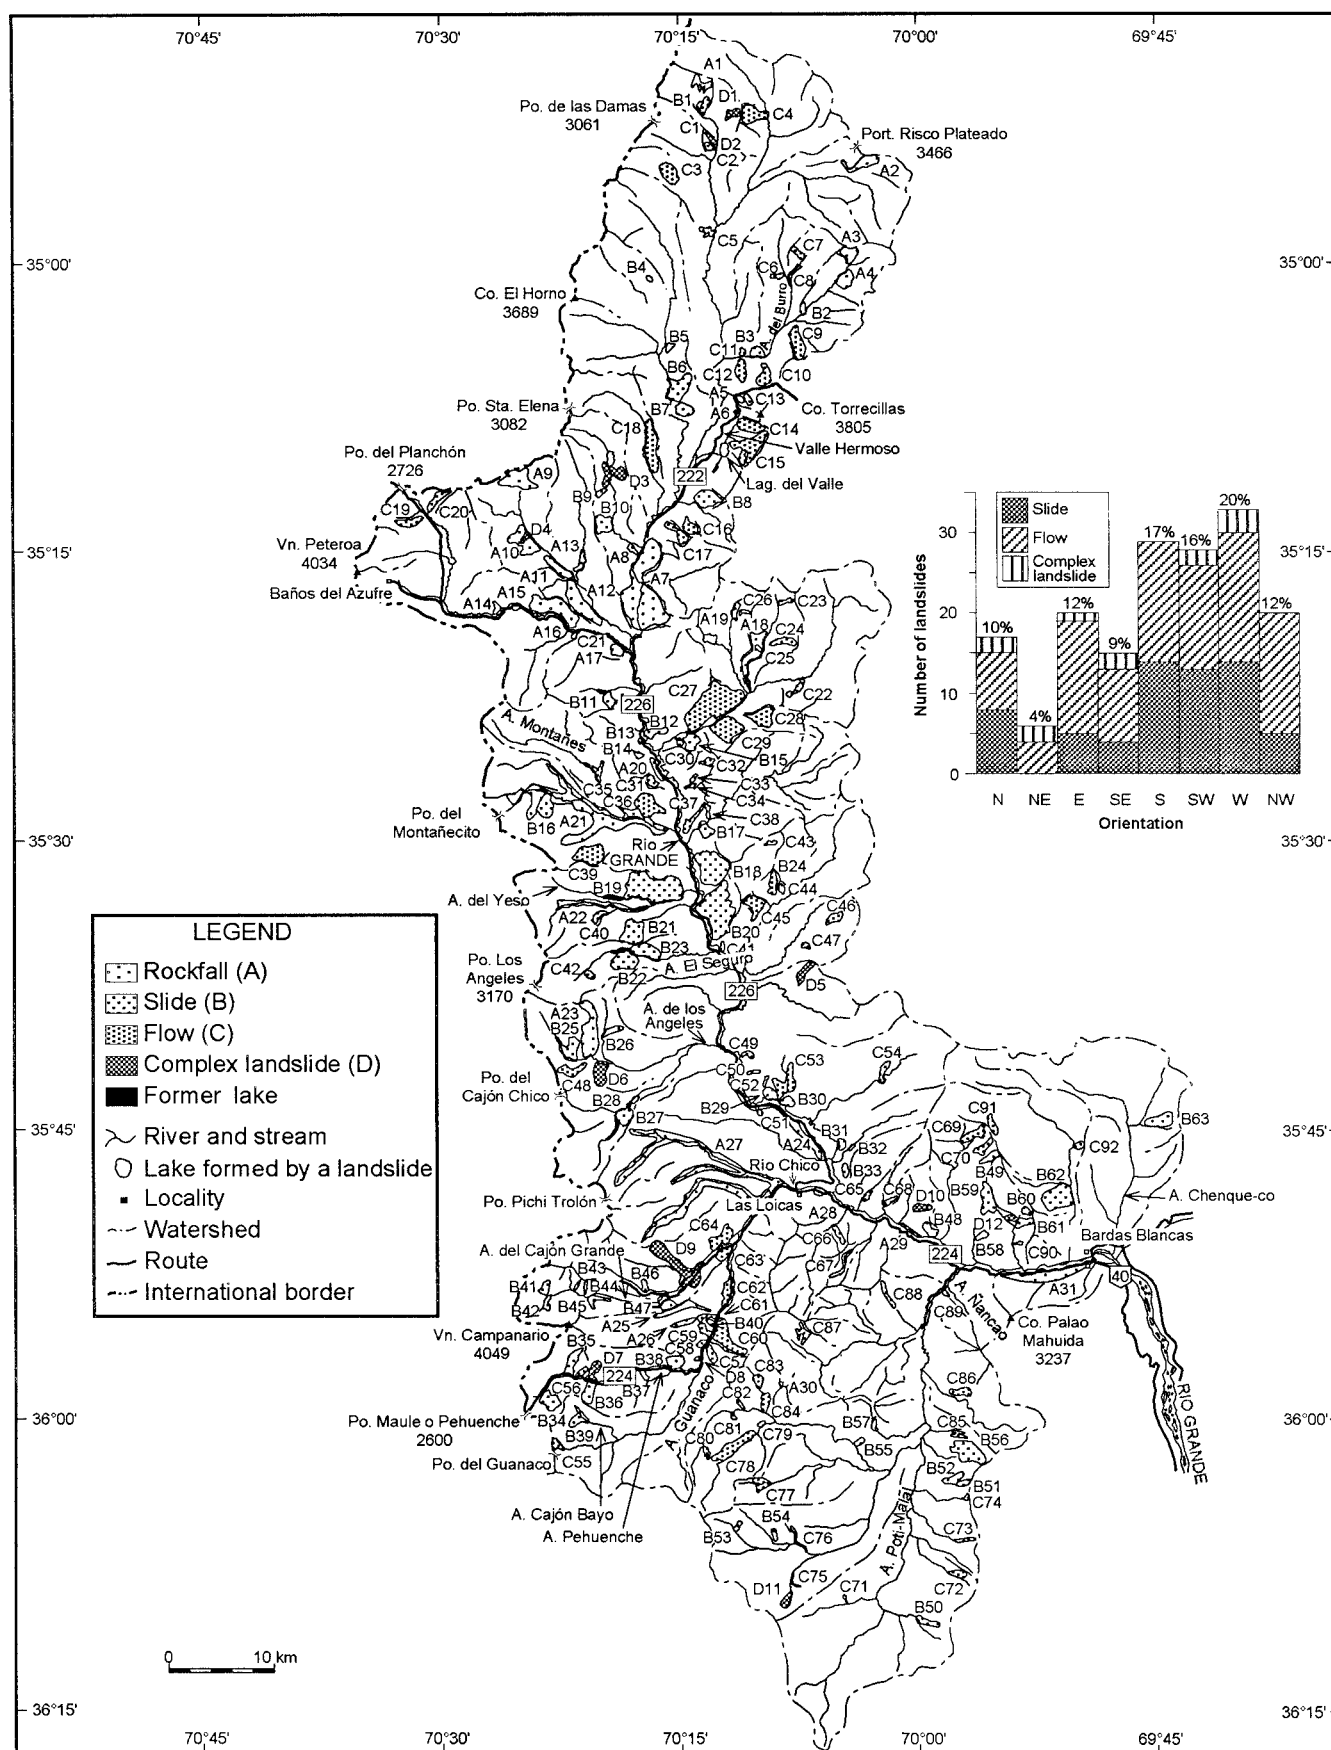
FIGURE 5 Inventory and location of landslides in the study area in the Río Grande basin.

The Río Grande valley has a north–south trend. Analyzing the orientation of 198 landslides represented in Figure 5, the flows, slides, and complex landslides are preferably oriented toward the west, south, and south-west. The predominance of flows and slides oriented toward the south and to the west is partly the result of those slopes being colder; they accumulate more snow and it remains there longer. Therefore, during the snowmelt season the amount of water is higher. The snow that remains in the cold slopes produces a more intense chemical and physical weathering of the rock, because of the presence of water in cracks and caverns, which freezes and thaws, and the hydration of clays and anhydrite.

We prepared 2 maps. The distribution and classification of landslides are shown on the first map (inventory map; Figure 5). The second—a landslide hazard and risk zonation map (Figure 6)—was prepared taking into account the zones subject to landslide hazard and the degree of loss to a given element or set of elements at risk in the region because of the occurrence of a particular phenomenon of a given magnitude (Coburn et al 1994).
