## **Restoration of a Coastal Wetland at Prisoners Harbor, Santa Cruz Island, Channel Islands National Park, California**

Authors: Power, Paula J., Wagner, Joel, Martin, Mike, and Denn, Marie

Source: *Monographs of the Western North American Naturalist*, 7(1) :  
442-454

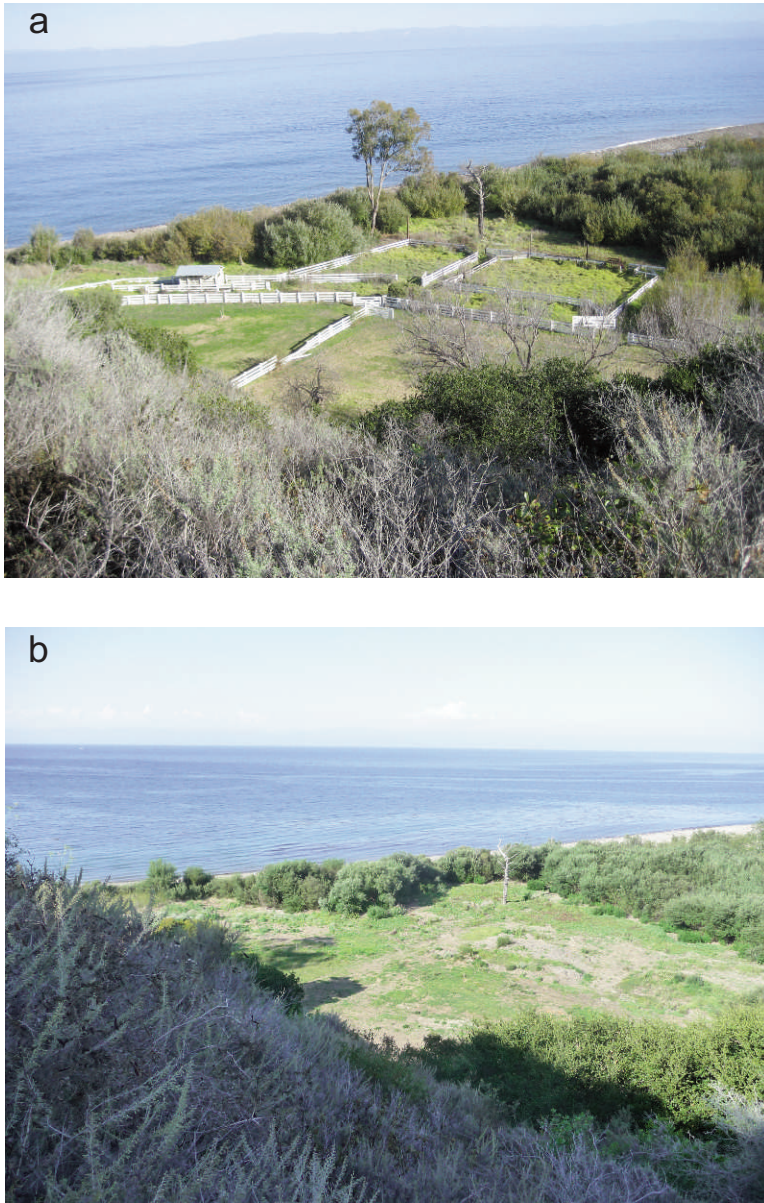
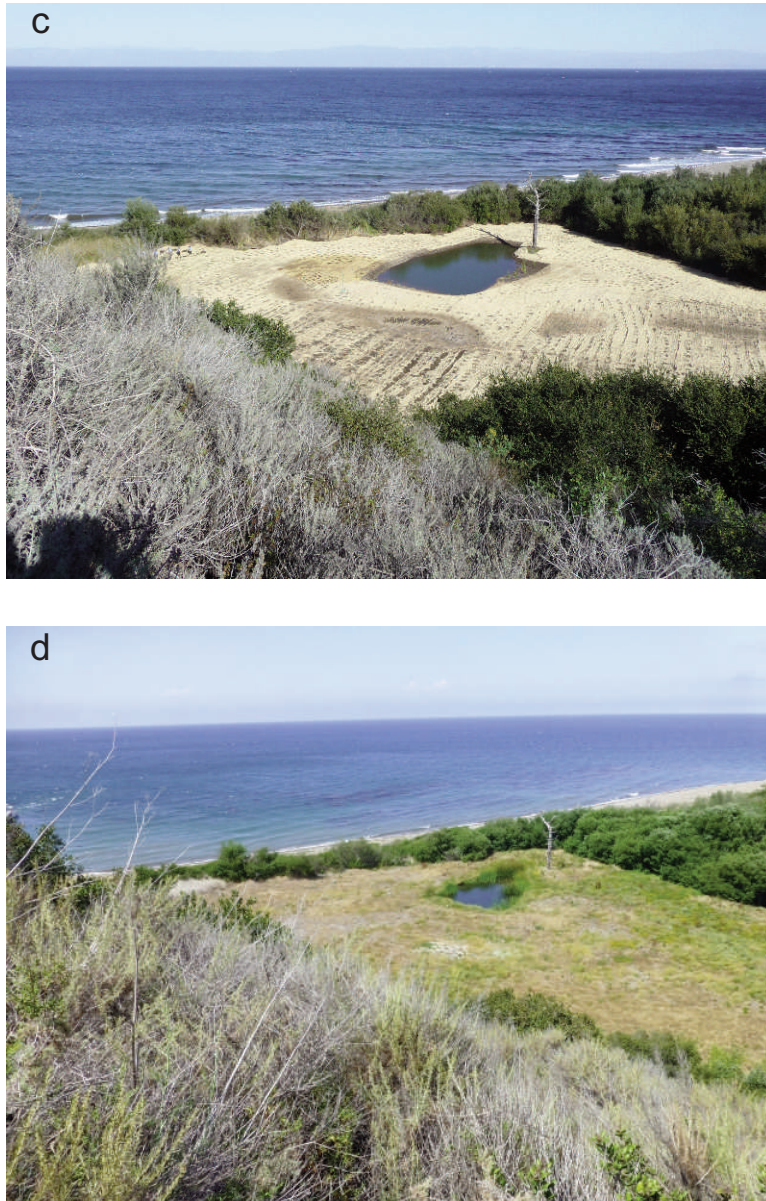
Fig. 4. Continued.

Fig. 4. Prisoners Harbor restoration area looking northeast: **a**, prior to project implementation in January 2010; **b**, prior to excavation in September 2011; **c**, immediately after native plant installation in December 2012; **d**, 18 months after project implementation in June 2013.

Table 1 shows the results for  $1 \times 1\text{-m}$  quadrat vegetation monitoring in 2012 compared to 2013. Of the 8 herbaceous species planted, abundance (% frequency) of one species, *Baccharis douglasii*, increased significantly from 1.3% to 4.4% (chi-square value  $P = 0.01$ ). There was no significant change in *D. spicata*, *Juncus mexicanus*, *S. californicus*, *Schoenoplectus maritimus*, and *Schoenoplectus pungens*. *Juncus patens* declined in abundance significantly, and *Juncus xiphioides* was not observed during 2013 monitoring (chi-square value  $P = 0.02$  and  $P = 0.00$ , respectively). Photomonitoring also documented vegetation change on a landscape scale over this period (Fig. 4).
