## **Landslide Hazard and Risk Zonation Mapping in the Río Grande Basin, Central Andes of Mendoza, Argentina**

Authors: Espizua, Lydia Elena, and Bengochea, Jorge Daniel

Source: Mountain Research and Development, 22(2) : 177-185

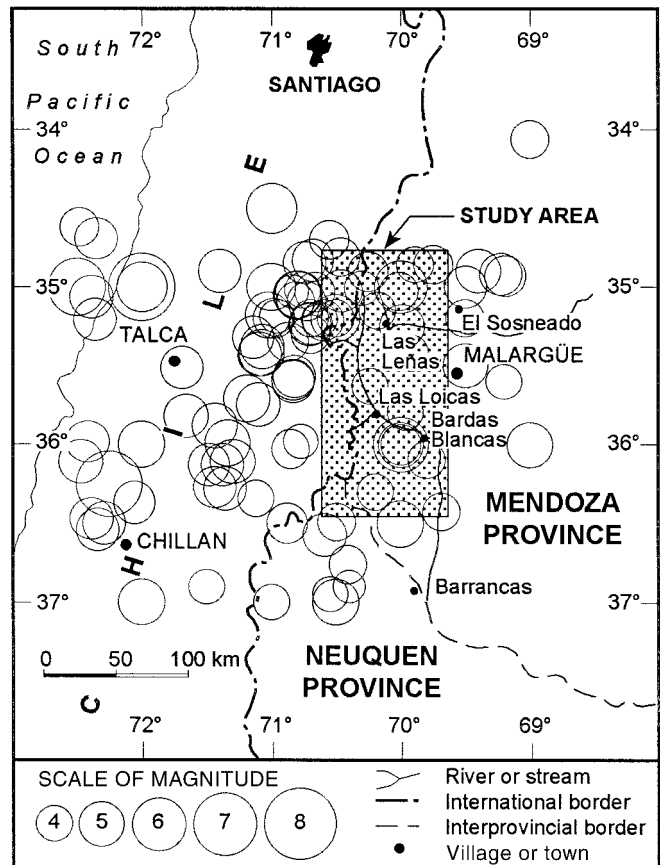
**FIGURE 3** Location of earthquakes (epicenters and magnitudes).

sity of Chile. Ninety earthquakes with magnitudes greater than 4 have occurred in the area. Figure 3 shows the location of the epicenters and magnitudes in the study area and the surrounding zones; the figure shows that there is an increase in the number of earthquakes and in their magnitudes toward the west.
